# TSX BROADWAY—POST-TENSIONED TRANSFER GIRDERS AND THE RAISING OF THE PALACE

BY J. BENJAMIN ALPER AND CAWSIE JIJINA

TSX Broadway and the Palace Theatre Renovation together are a project with numerous complex pieces, each of which required unique design approaches to solve complex problems using time-tested techniques but applied in innovative ways. The Palace Theatre and the former DoubleTree Hotel sat at 1568 Broadway, the intersection of 7th Avenue and 47th Street, in the heart of Times Square in New York City (Fig. 1).

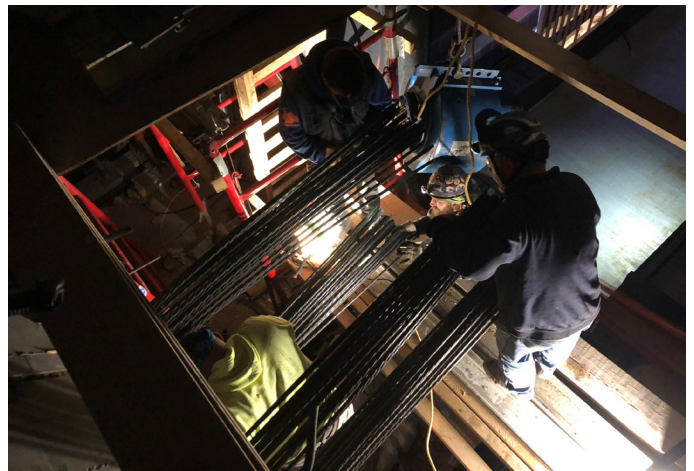
Fig. 7—Jacking operations

manager, arranged for a series of design charrettes that were held with various key players, who each used their expertise to help refine and develop the design. Howard I Shapiro and Associates, the Shoring engineers, consulted on the coordination of multiple shoring systems to ensure that the sequencing was feasible without overstressing the existing structure below. Methods for reducing the loading to structure, such as the early PT sequence for the middle girder, were proposed and integrated into the design. VSL/Structural Group, the specialty PT subcontractor, reviewed phasing of the construction and helped introduce methods to resolve congestion. For example, the initial design used tendons with a maximum of 31 strands per tendon. VSL proposed the use of up to 43 strands per tendon, with a total jacking force of up to 2,017 kip (8,972 kN) (Fig. 7 and 8). This meant that

special jacks needed to be brought in from overseas and had to be calibrated at Lehigh University's laboratory as few laboratories in the United States could handle jacks of this size and power. Sorbara, the concrete subcontractor, coordinated amongst their various suppliers and was critical in discussions related to the logistics of placing 14 ksi (97 MPa) concrete, 15 floors (185 ft [56 m] above street level) in the air on one of the busiest corners in the world.

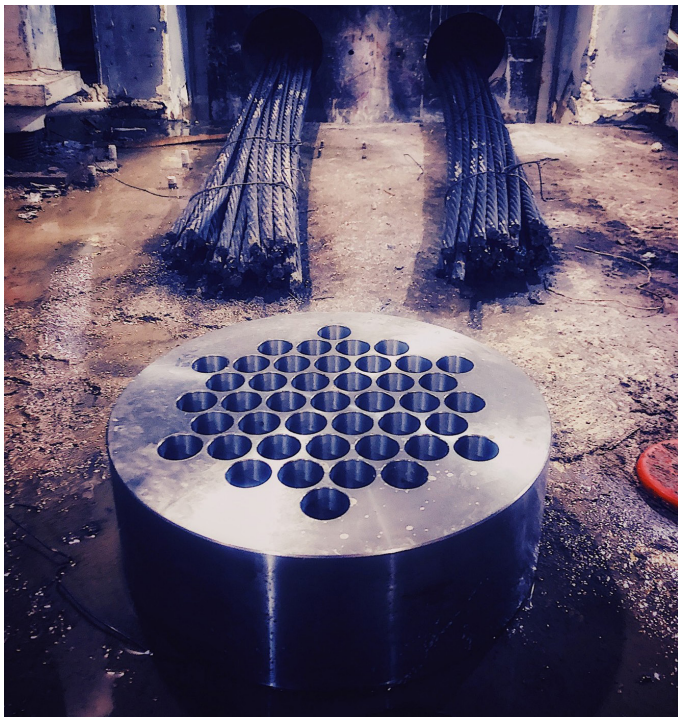
Fig. 9—PT end fittings

The final design of the PT girders consisted of the three girders each being tensed in five stages, with the center girder having half of the first stage tensioned early to resolve the shoring requirements as previously mentioned. The girders had two to four tendons per stage with each tendon having 31 or 43 strands each (Fig. 9). Therefore, each girder has approximately 500 strands.

Each seven-wire strand is 0.6 in. (15 mm) in diameter with an area of 0.217 in.<sup>2</sup> (140 mm<sup>2</sup>). This generated a total jacking force of approximately 22,000 kip (97,860 kN) with a drape of approximately 40 ft (12.2 m), inducing an upward-induced moment of approximately 880,000 k-ft (1,193,100 kNm) (Note: numbers are approximate and do not include losses). The complexity of the staged tensioning required that the transfer girders be checked at the many combinations of the different concrete placement heights, and the induced forces each time the girder was tensioned, as areas would see both tension and compression at different stages.

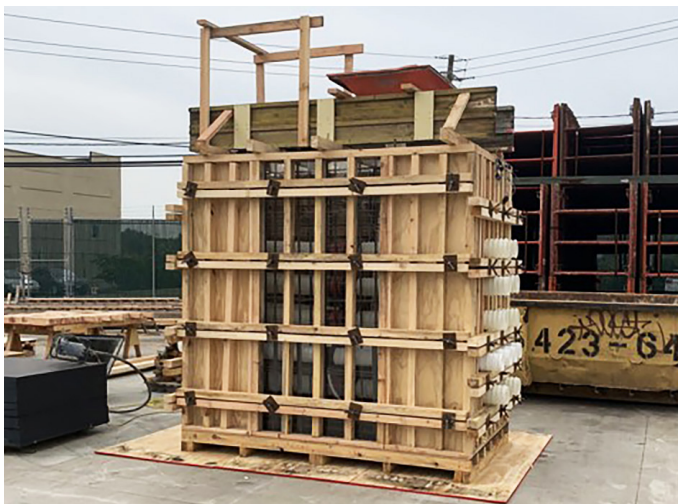
Fig. 11—PT girder mockup

The mockup was 8 ft (2.43 m) long and 8 ft (2.43 m) wide and the full depth of the actual girder (Fig. 11). The reinforcement bars and conduits representing the PT strands were placed in the mockup to match the actual design. One wall of the formwork was replaced with plexi-glass so we could observe the flow of the concrete. As the concrete used was self-consolidating concrete, vibration was not required but verification of a smooth flow around all the reinforcement was critical. The mockup was built in a yard in New Jersey and the concrete truck arrived within 30 minutes of being batched. As the travel time to site can vary significantly based on traffic, the truck was held for additional time to simulate the actual expected field conditions and delays in Times Square. A total of 18 Hilti Concrete Sensors were placed in a pre-planned grid pattern throughout the mockup to monitor concrete temperatures during the placement. A warm summer day was chosen to represent the expected New York summer weather.

The results showed that the congestion and workability of the concrete achieved the design intent. However, concrete temperatures were borderline and approached allowable limits. During the mockup, concrete temperature reached 163°F (72.8°C), exceeding the allowable 160°F (71.1°C) threshold. Sensors showed that the temperature gradient within the girder cross-section also exceeded the upper bound. The concrete mixture already used 40 percent cement replacement and had concrete additives to slow the heat of hydration.

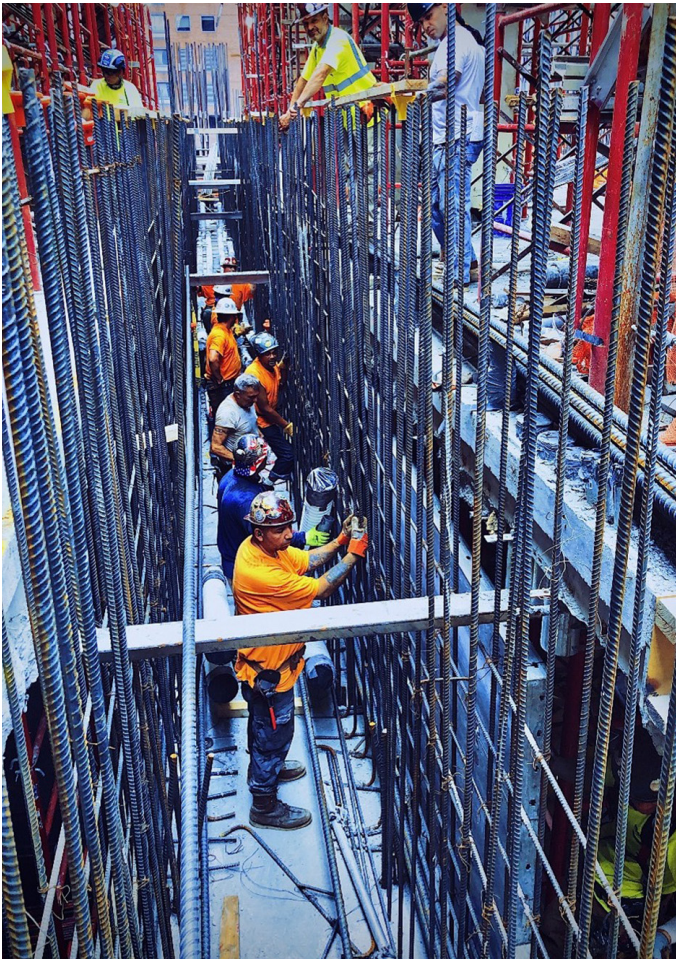
Fig. 14—PT girder construction

In general, the pre-planning and mockup proved to be extremely helpful in resolving issues in advance. The PT conduits, reinforcing bar, embedments, and so on, all

fit with minimal issues and adequate workability (Fig. 14 and 15). There were some issues encountered during construction which the team had to resolve.
