Seventh Avenue intersect in New York City. When finished, 20 Times Square will host a variety of functions, including nearly 75,000 square feet of premium retail space and 30,000 square feet of multi-function entertainment spaces, with a premier nightclub and a 7,000 square foot rooftop terrace that overlooks the heart of Times Square. Nestled between the retail space and rooftop is a 150,000 square foot high-end hotel with 452 guest rooms (to be branded as a Marriott Edition, the collaboration between Ian Schrager and Marriott Hotels) and an 18,000 square foot hi-definition LED sign, rising 120 feet above the bustling streets below and wrapping around both the 47th Street and Seventh Avenue facades.

The Challenges

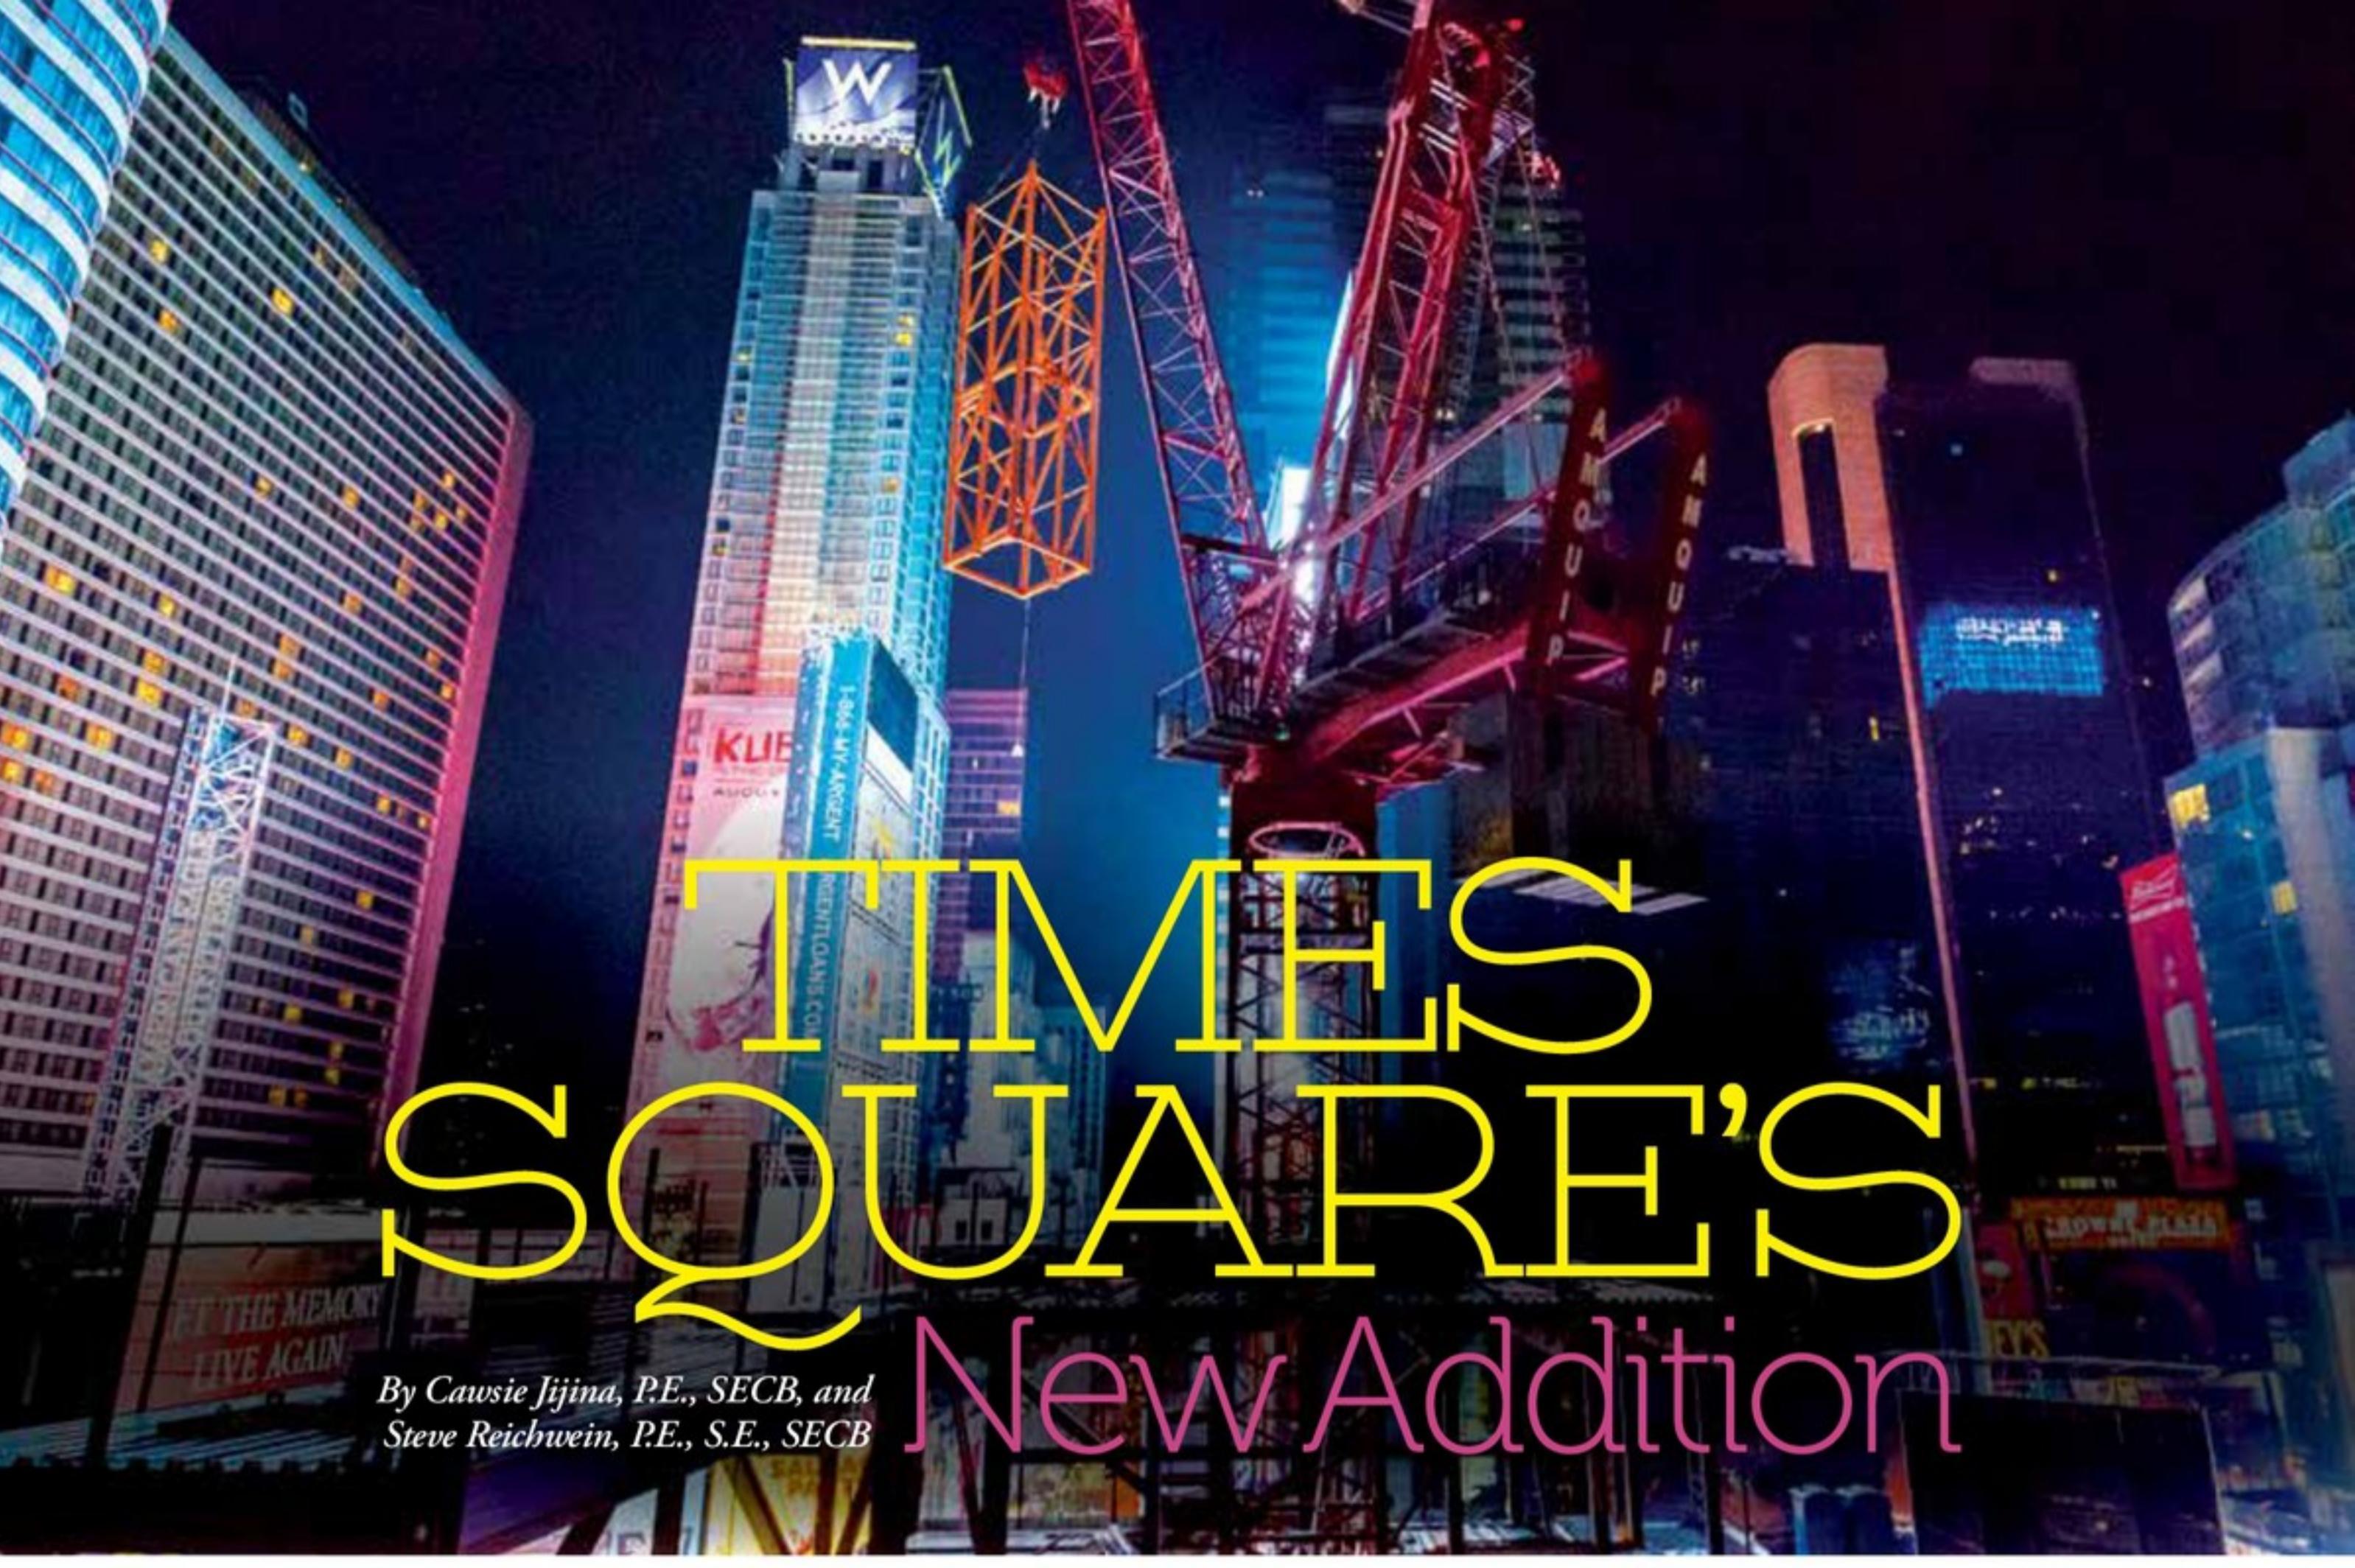
Night construction. Courtesy of Ralph D'Angelo.

While this system posed the most challenges to the design, logistics, and capital cost, it was the most efficient from a schedule perspective and saved a month when compared to other options. The trades were orchestrated to execute like opera performers on a two- and three-shift operation and included steel erected at night.

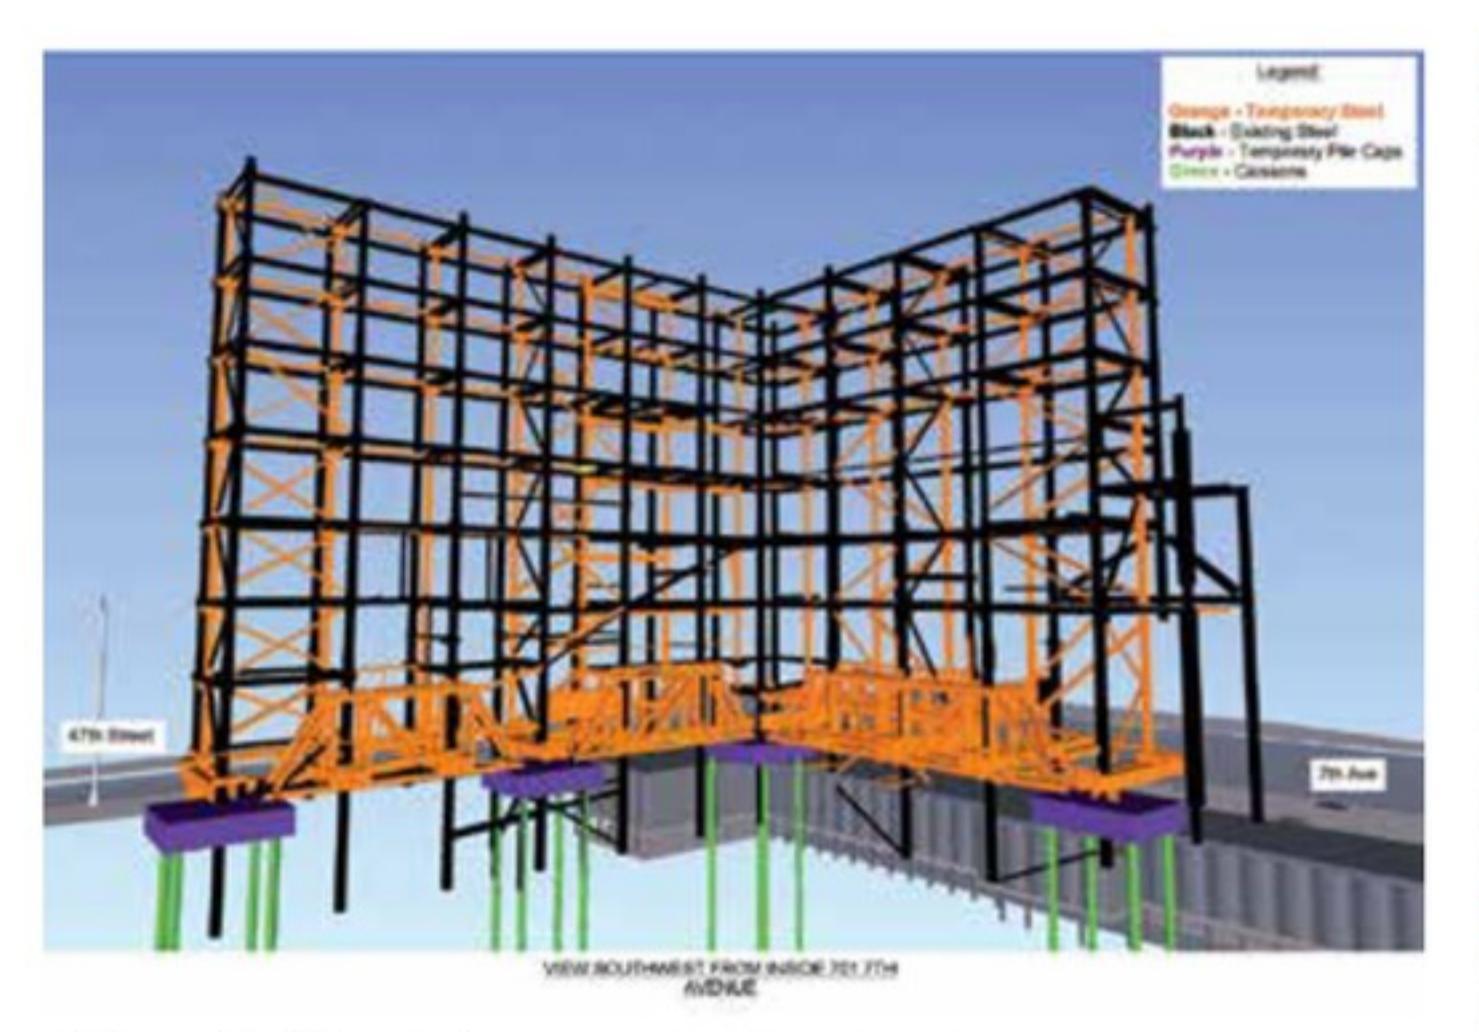
BIM model of the existing structure and temporary support structure. Courtesy of CNY.

very intricate bracing system was introduced (designed by Howard Shapiro and Associates) to open key areas of the site to excavation crews while maintaining the stability of the existing structure that was to remain. This temporary bracing system was comprised of two forty-foot-long Pratt Trusses above the ground floor, caisson supported mast towers (which were extended along with the excavation), elevated caisson caps, braced frames, shoring columns, and shoring header beams. Unknown existing structural conditions warranted full-time site supervision by Howard Shapiro and Associates during installation of the temporary bracing and stability systems. Due to the limited documentation, a three-dimensional laser scan survey was conducted on the architectural shell early in the project and of the existing structure later as the project developed. Additionally, the temporary bracing structure was installed to suit the multitude of different field conditions, which arose during inception. Thus, the laser scan also served as a three-dimensional as-built rendering of the temporary bracing and stability structure. Once the existing and temporary bracing structures

were modeled as three-dimensional masses, utilizing point cloud data obtained by the laser scan survey, the new structure was coordinated and designed to avoid conflicts with both the existing structure to remain and the temporary structure. This coordination effort ultimately eased the installation of the new structural framing, saving the construction team and owner crucial time and money.

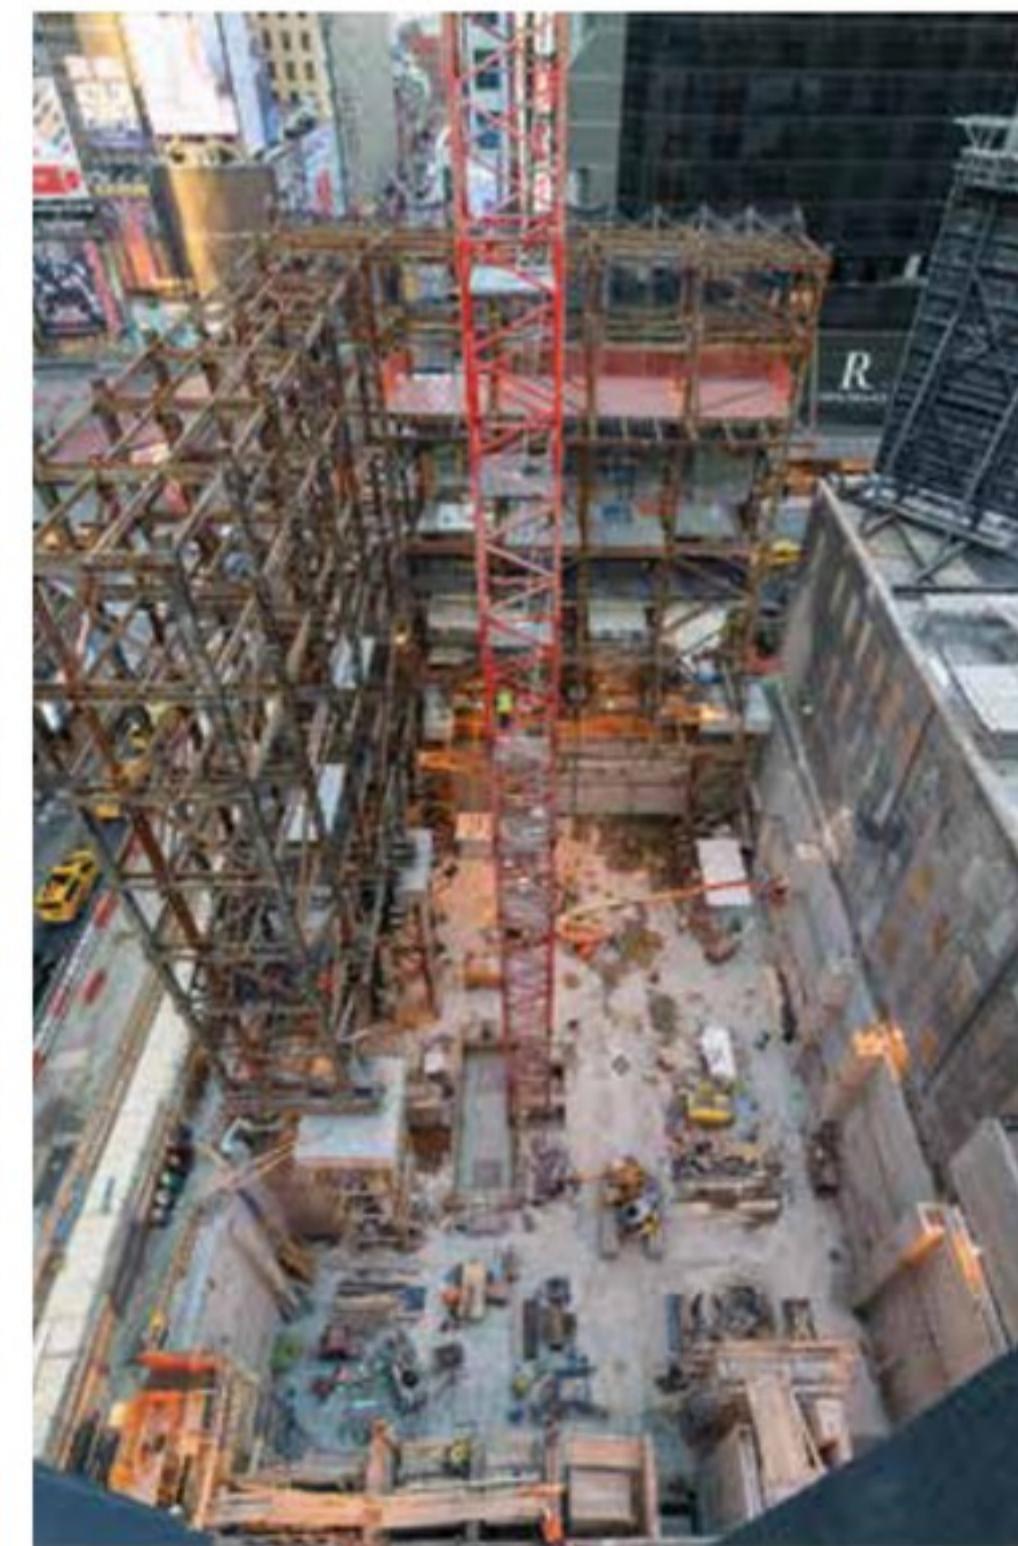
Overall view of the site at the completion of foundations. Courtesy of Ralph D'Angelo.

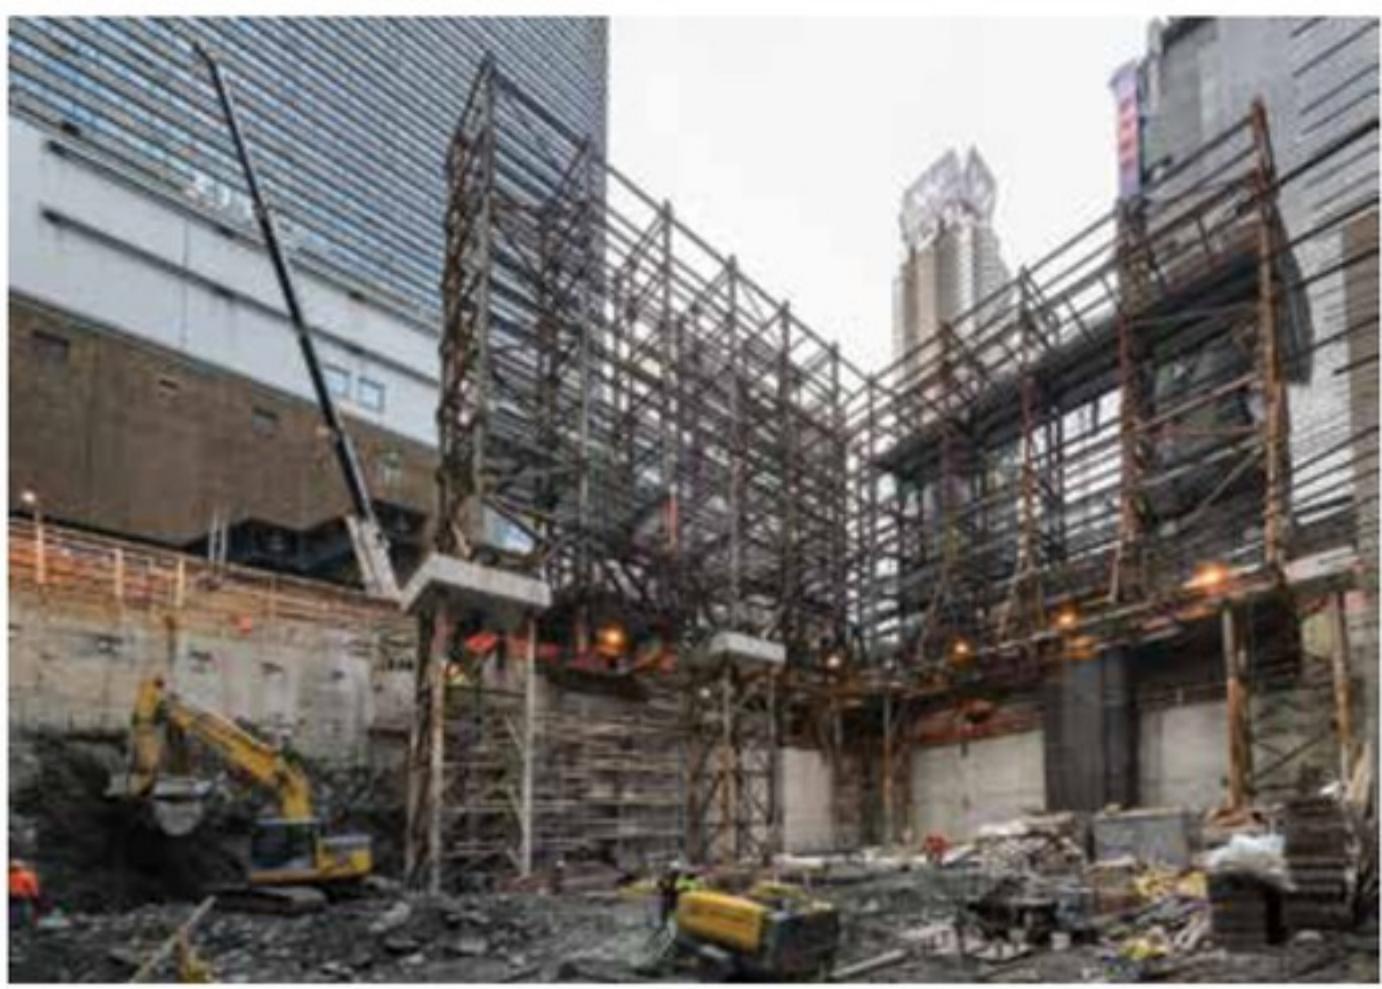
An as-built photograph of the existing structure and temporary support structure. Courtesy of Ralph D'Angelo.

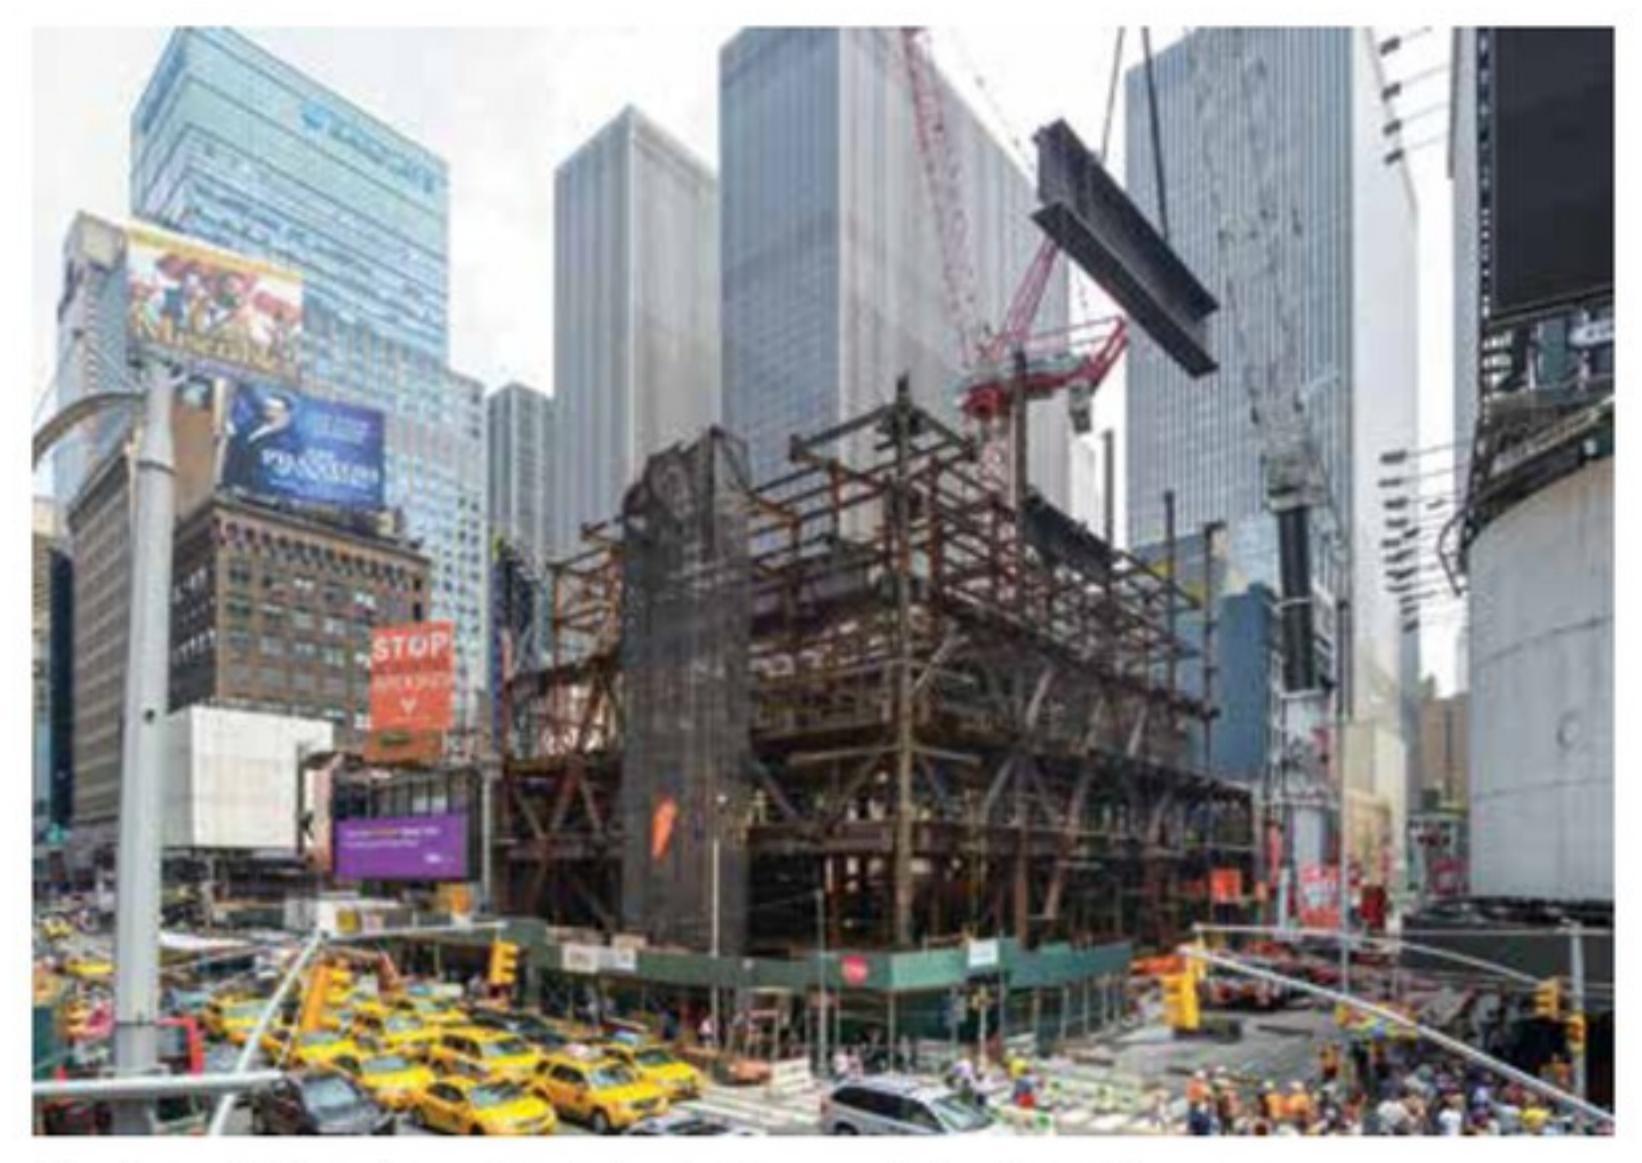
Erecting a 10-foot-deep plate girder for the seventh level transfer system. Courtesy of Ralph D'Angelo.

columns. A well-positioned mechanical level served as the dividing line between the hotel and the retail spaces; nestled in this vast space of mechanical equipment, the transfer structure that supports the hotel tower was proposed. Thirty-five plate girders, ranging in depth from 36 inches to 120 inches, transfer the concrete columns, the largest of which was a ten-foot-deep by three-foot-wide element weighing more than 120,000 pounds.

Fortunately, the lot-line shear wall transfers directly onto a structural steel braced frame below, and one of the shear wall cores spanned from foundation to roof. However, the main hotel elevator core, comprised of two, C-shaped shear walls, transfers to create a vast open retail space below. Two parallel 60-ton Transfer Trusses accomplish the Hotel Core Transfer and deliver the gravity load to four super columns each weighing about 1,200 pounds per linear foot. The lateral forces are transferred through reinforced 9th Floor and 7th Floor slabs that serve as diaphragms, and the combined system delivers all of the hotel tower's forces to the structural steel system of the Retail-Entertainment Podium.
