# Growing UP in Manhattan

BY ANDREW MUELLER-LUST, P.E.

**Well-studied use of structural steel allows Bank of America Tower to rise in New York City.**

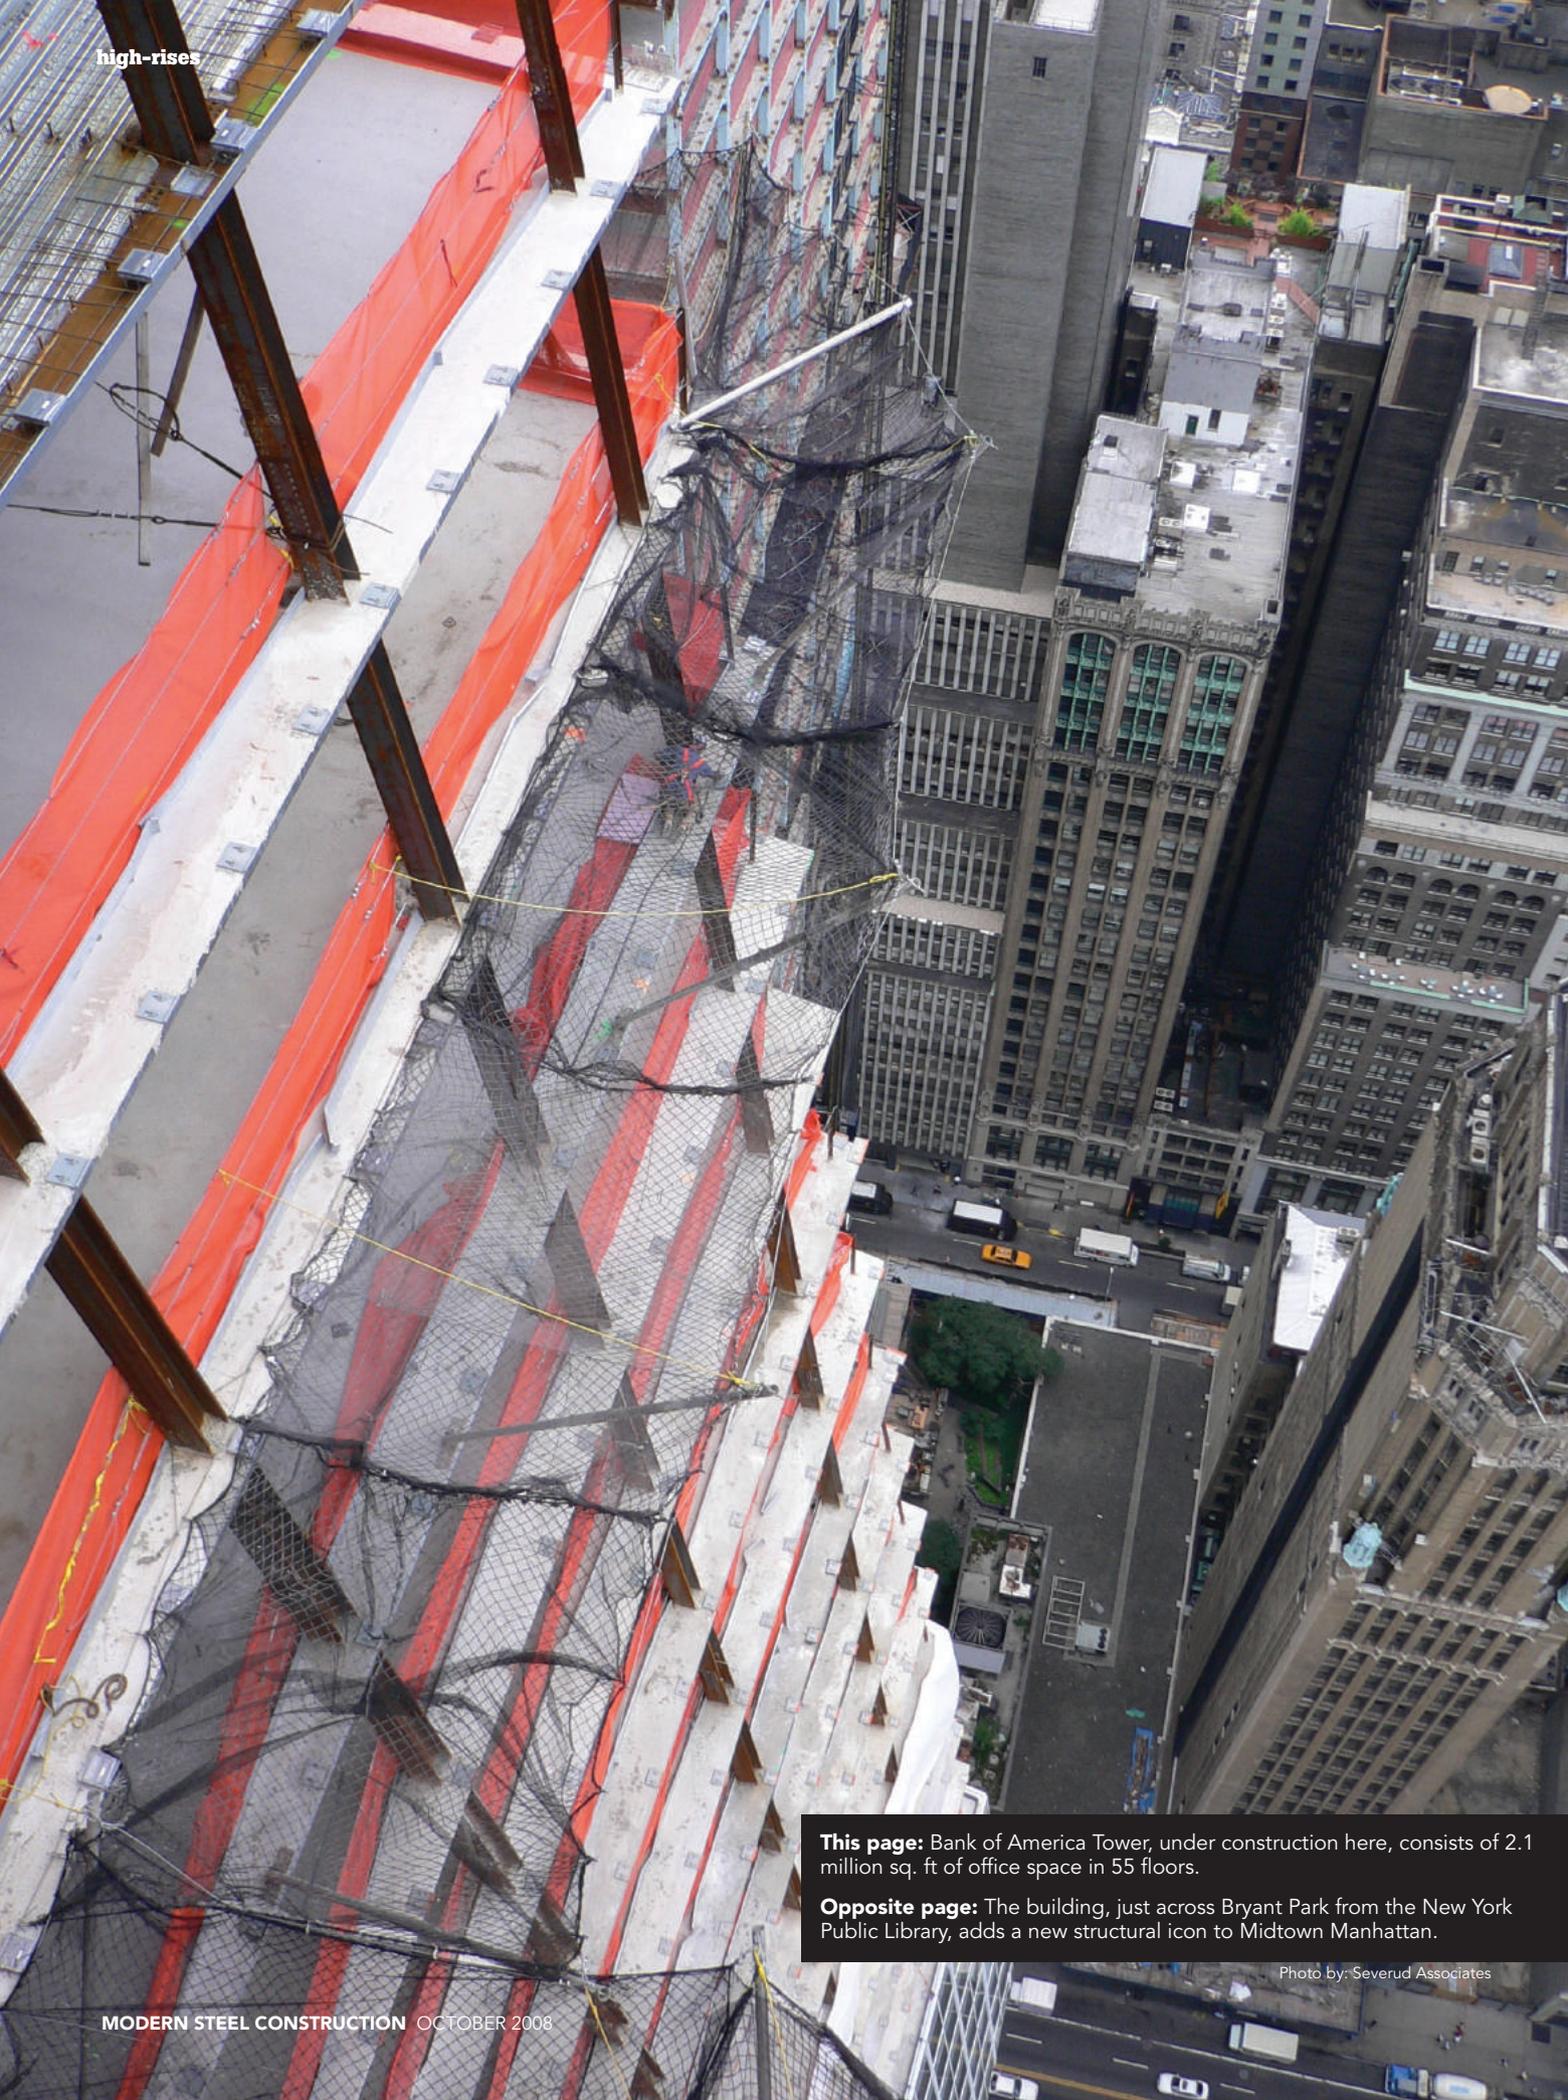
**This page:** Bank of America Tower, under construction here, consists of 2.1 million sq. ft of office space in 55 floors.

**Opposite page:** The building, just across Bryant Park from the New York Public Library, adds a new structural icon to Midtown Manhattan.

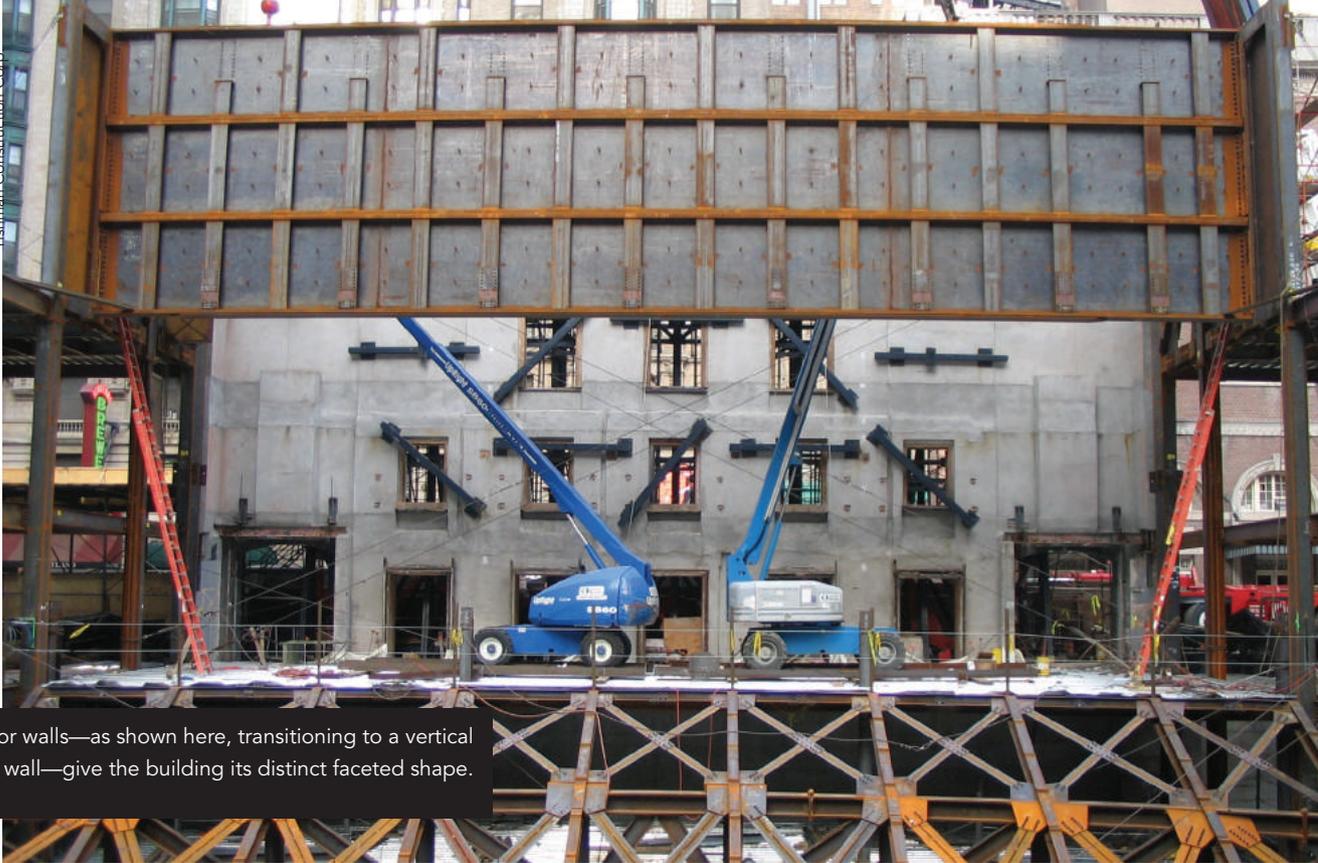
Sloped exterior walls—as shown here, transitioning to a vertical wall—give the building its distinct faceted shape.

gated to accommodate the sloping surfaces of the façade. Keeping the columns vertical and transferring them every few floors produced transfer girders much too deep to fit above the ceilings. Even stepping the columns—i.e., offsetting vertical columns at every floor—proved infeasible, especially at the lower floors; although each individual offset is small, the shear that would have to be transferred is very high.

Sloped columns, alternatively, allowed for a smooth transfer of vertical load while having the least architectural impact as well. Still, the induced horizontal loads had to be taken into account, especially at the transition from vertical to sloped. At most locations, this was handled with an upsized tie beam and connection. At the 3rd, 4th, 11th, and 12th floors, however, where all of the columns at the southeast corner of the building slope inward simultaneously, horizontal trusses were necessary to deliver the large lateral loads to the core shear walls.
